Development Report

B-52/KC-135 COLLISION

NEAR PALOMARES, SPAIN (U)

S. V. Asselin, 1544
Sandia Laboratory, Albuquerque

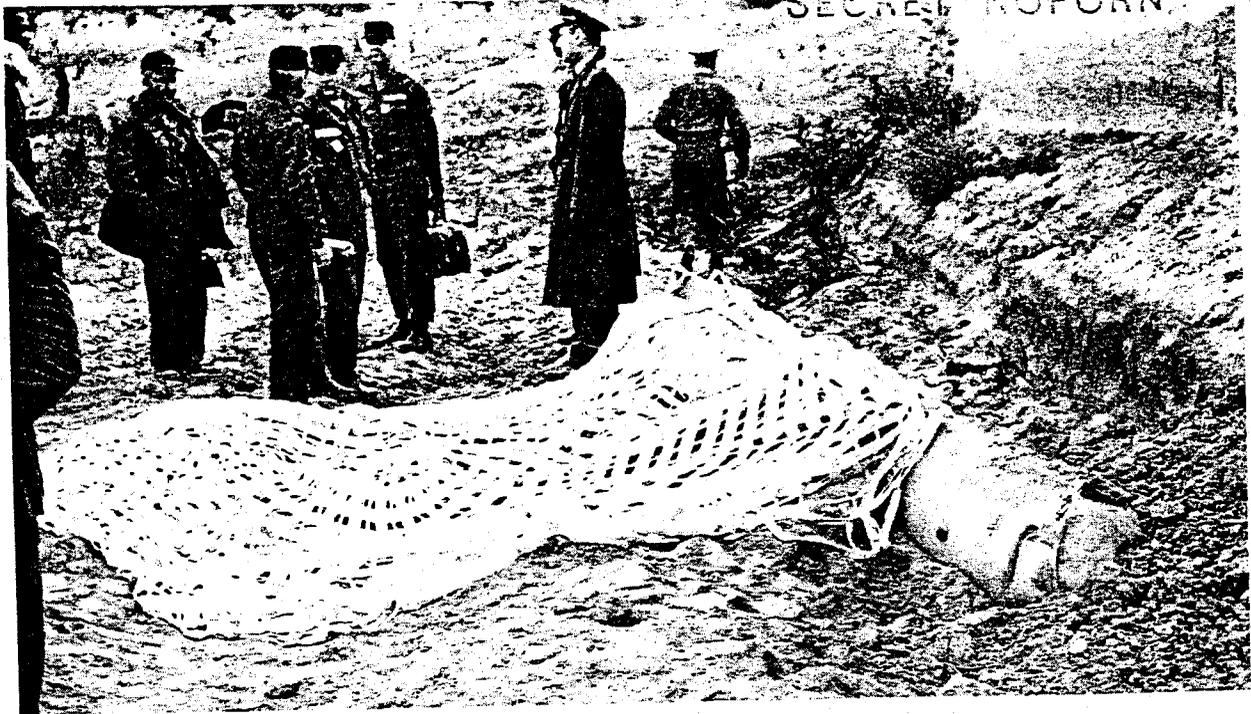
Figure 5. Weapon #1

Weapon #1 (Left upper position in clip-in assembly) -- The weapon was in relatively intact condition, having been retarded by abnormal deployment of the 16-1/2 foot parachute and impacting on a steep bank of soft earth. The nose section of the fuze was crushed and dented and the afterbody (shape component) suffered a few dents. The tail plate and three fins were missing. The MB-3A

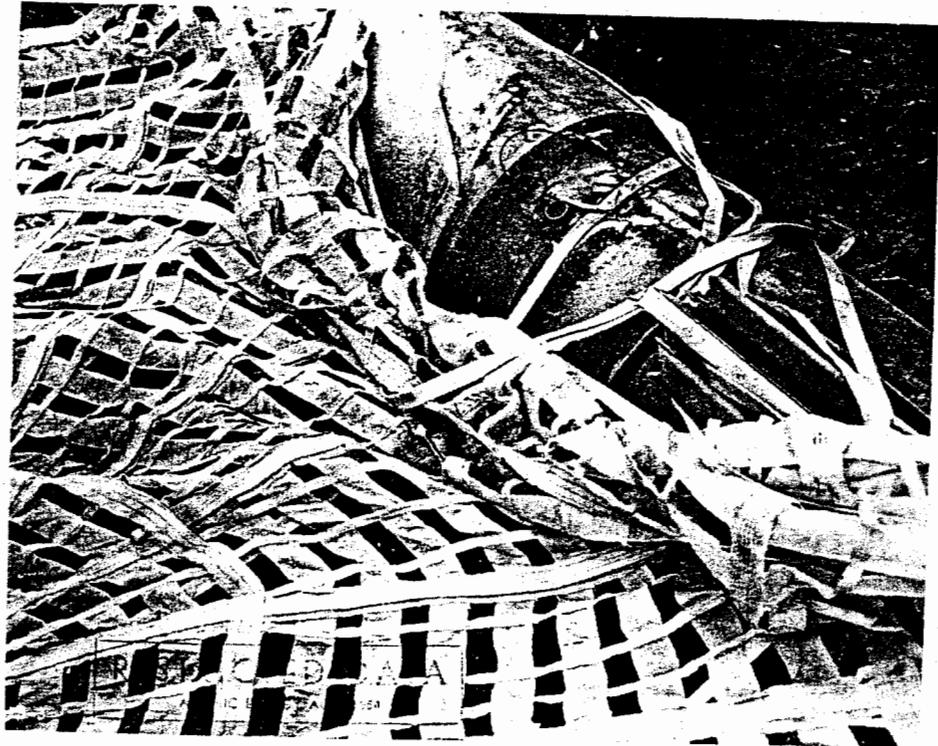
Figure 7. Weapon #1 (extracted pullout rod)

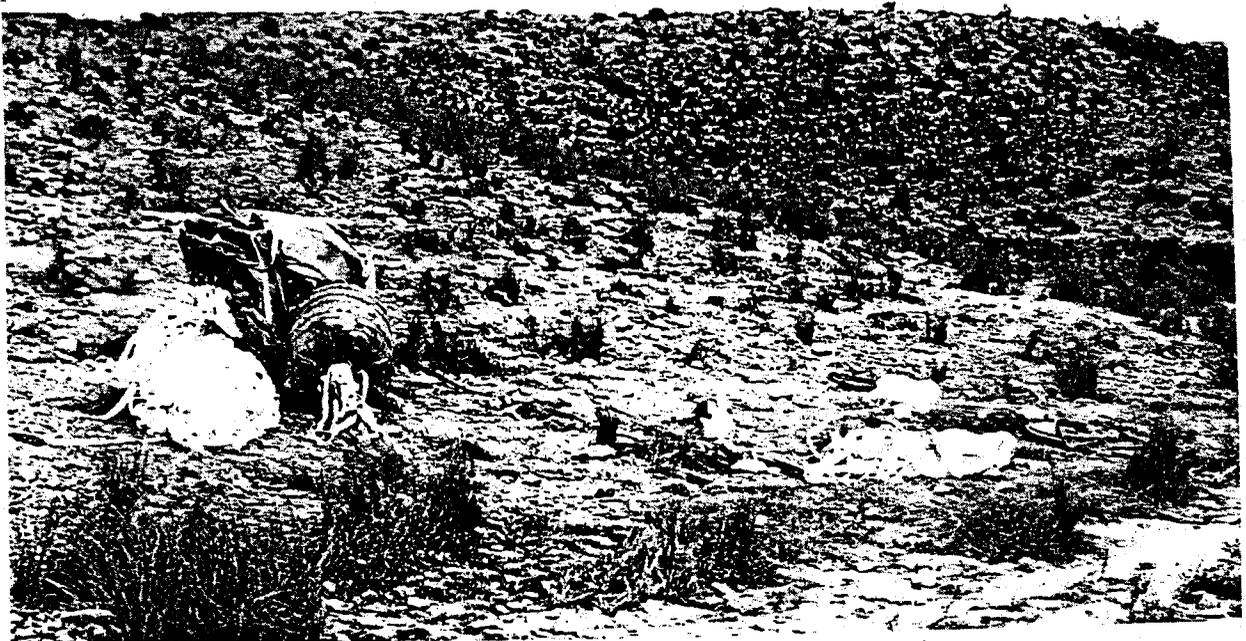
Figure 10. Weapon #2 Afterbody Debris

Parts of electrical components, structural material, and HE were scattered over a large area. The ready-safe switch was found; however, its crushed condition precluded visual monitoring. Extensive plutonium contamination surrounded the impact point. A discussion of the extent of plutonium contamination and the clean-up operation is contained in Appendix B.

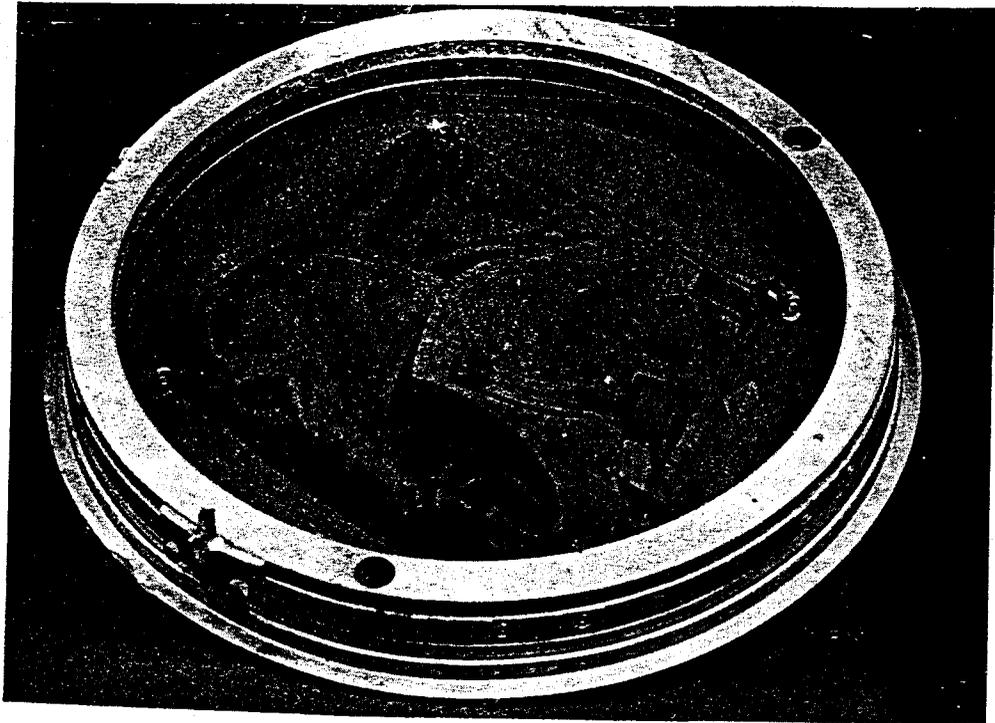
On January 19, a portion of the missing weapon was found in the temporary camp set up in a dry river bed near Palomares. It consisted of the tail closing plate attached in the normal manner to the rear ring forging of the afterbody (Figure 17). The ring had separated from the inner and outer skin sections of the afterbody at the riveted attachment points. This assembly was verified to have come from the fourth weapon by the identification of a rear ring forging on each of the remains of the other three weapons. Later investigation revealed that the assembly had impacted some distance from the camp on a steep hillside (Figure 4), and had been brought to the camp by a Guardia Civil who had been given the item by a local resident.

Figure 17. Weapon #4 Tail Plate and Ring Forging

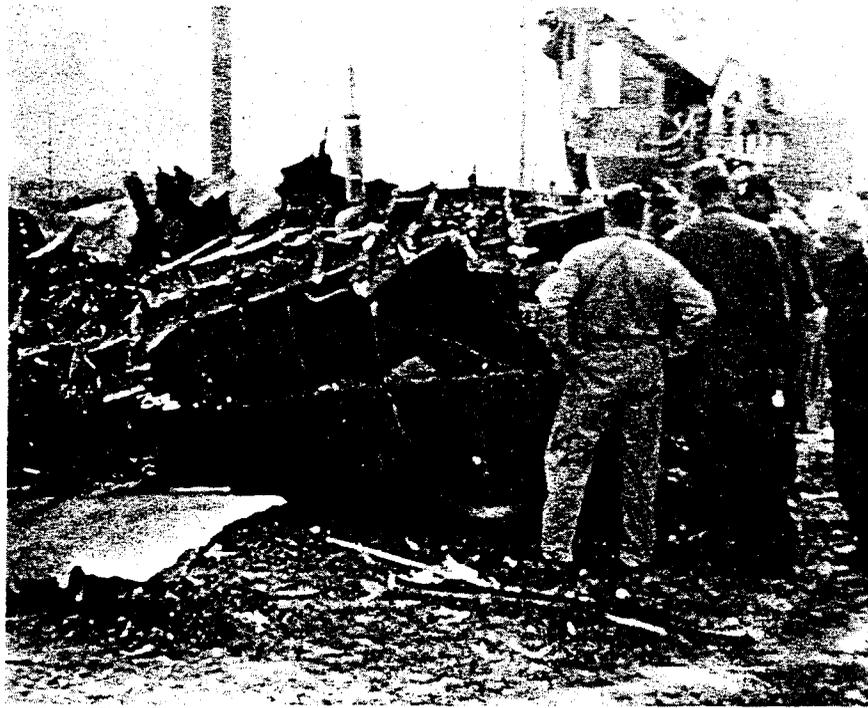
On January 22 and 23, the B-52 aircraft debris associated with the bomb bay was examined for information as to how the weapons left the aircraft. The center fuselage section (Figure 18) contained the rear bomb bay where Quail (ADM-20A) missiles were located. The break between this section and the forward portion of the B-52 was directly between the forward and rear bomb bays. There appeared to be no damage to the rear bomb bay caused by the Mk 28 weapons in the forward bomb bay.

Figure 18. Examination of Rear Bomb Bay, B-52

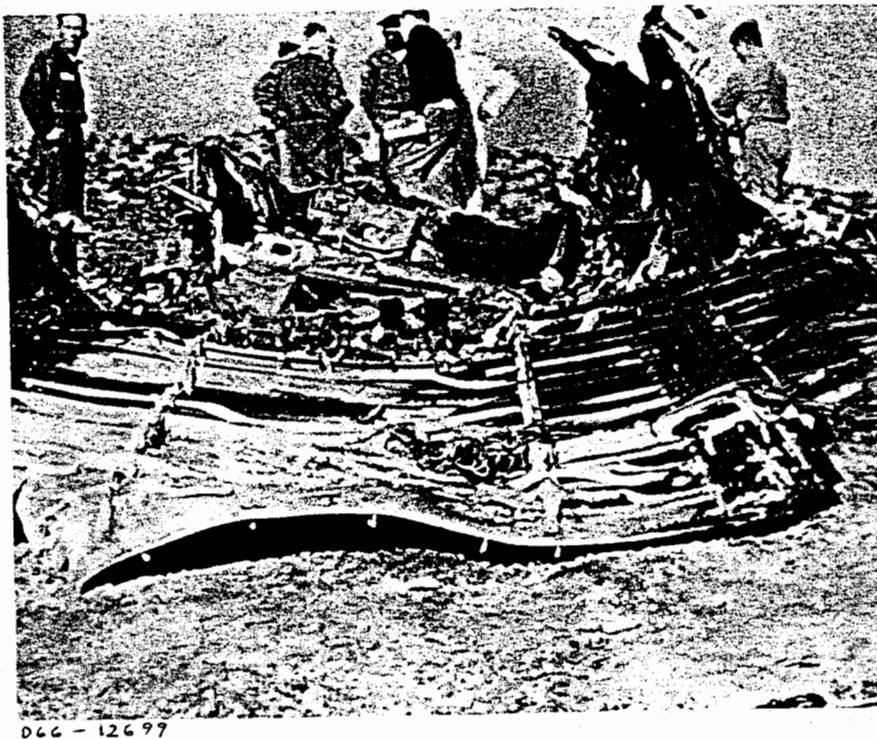
The forward portion of the B-52 had impacted on a small hillside and burned (Figure 19). The major portion of the MHU-20/C clip-in assembly, which was still in position in the bomb bay attached to the MAU-6/A clip-in rack, was removed for examination (Figure 20). No weapon racks remained with the clip-in assembly, and a portion of the vertical structure was missing. A major portion of the missing structure was found at sea in shallow water on January 31.

Figure 19. Examination of Forward Bomb Bay, B-52

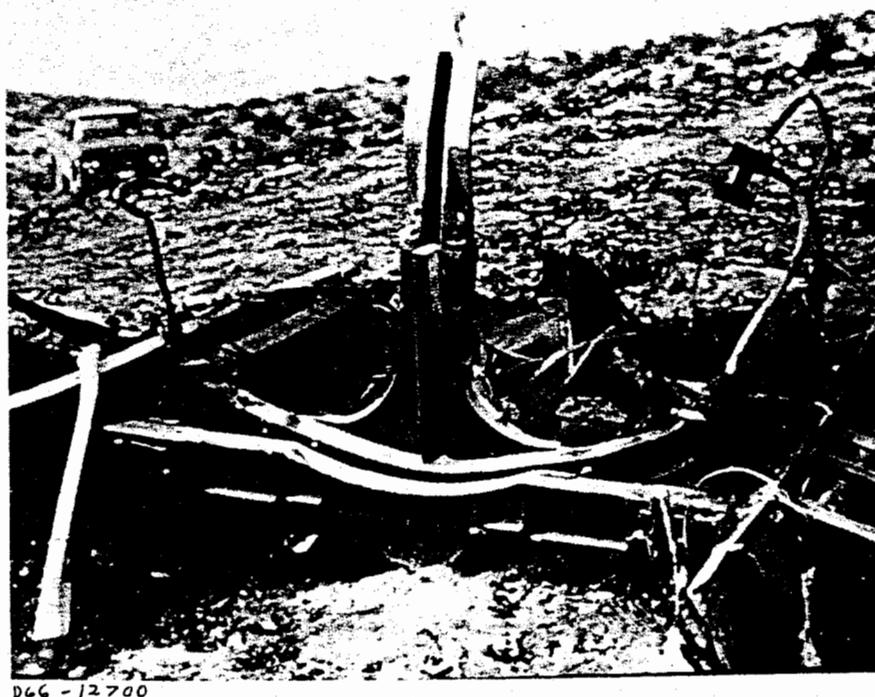
Figure 20. Remains of MHU-20/C Clip-In Assembly

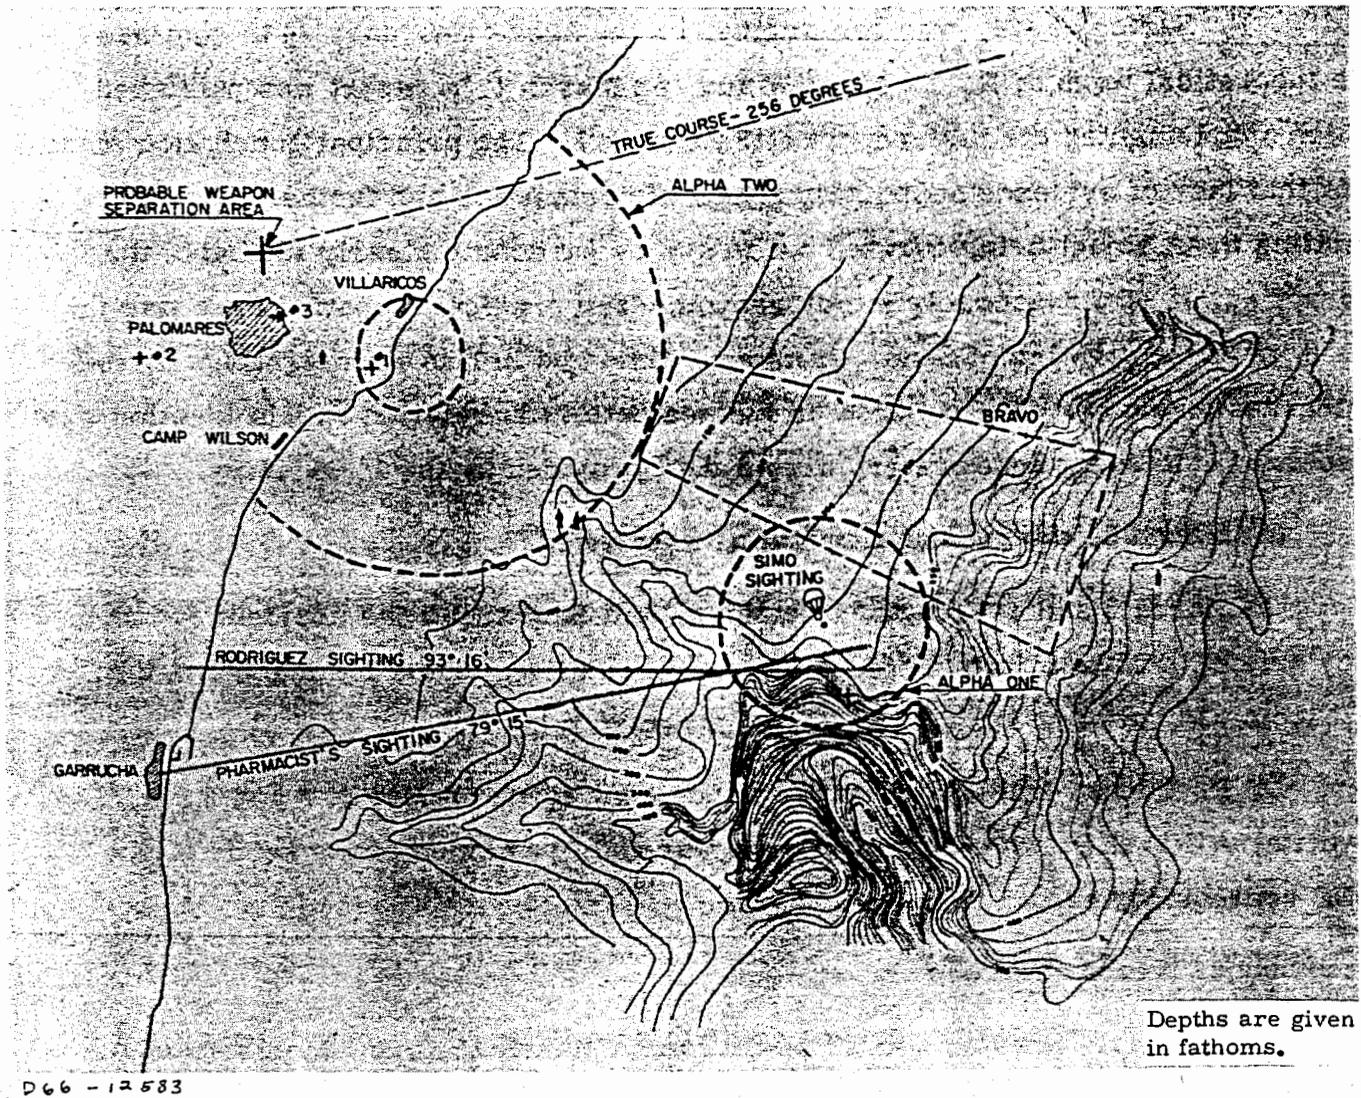
During an underwater search operation on March 15, crew members of the Alvin submersible discovered the missing weapon on a 70-degree slope at a depth of 2550 feet. The location was within the predicted impact area (Figure 21).

Small + in Alpha-One area is predicted bottom impact point with underwater currents accounted for. Large + in Alpha-One area is location of weapon when discovered on March 15.

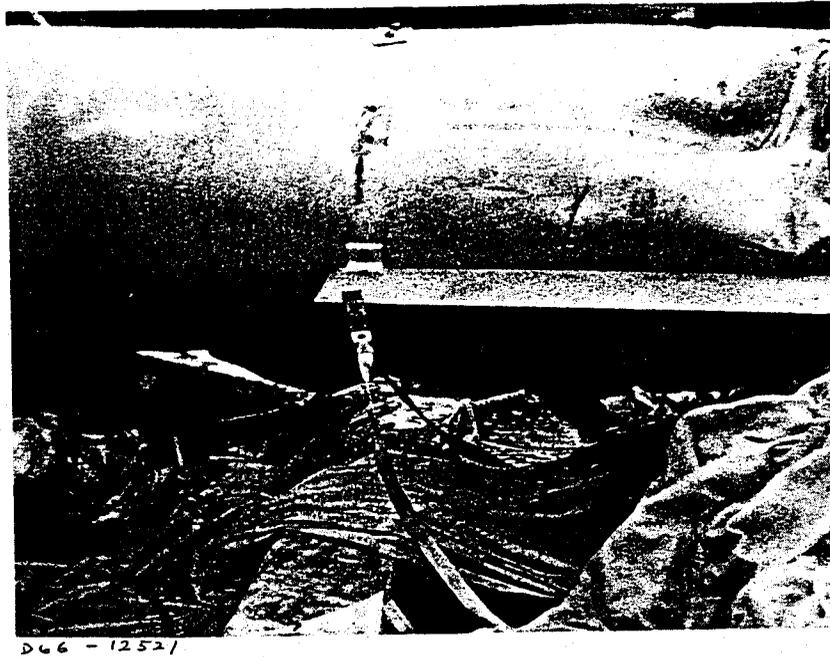
Figure 26. Weapon #4, Dents on Left Side of Afterbody

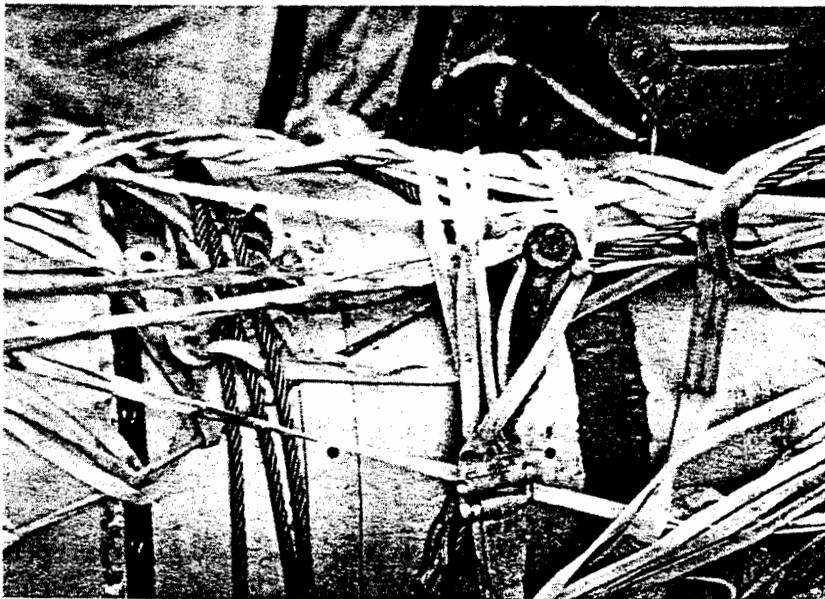
Figure 29. Weapon #4, Pullout Rods Extracted

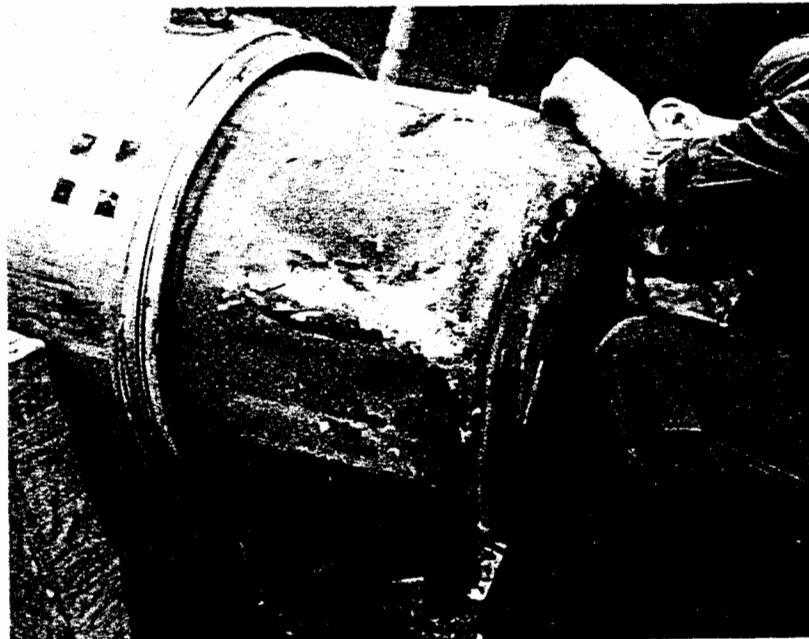
Removal of the fuze section revealed the effects of pressure on the warhead pressure cover (Figure 33). Apparently the pressure seal withheld the pressure during the crushing of the cover, and subsequent leakage filled the warhead with sea water.

Figure 33. Weapon #4, Crushed Warhead Pressure Cover

The cover had to be forced off by cutting, prying, and pulling (Figure 34). Components under the cover had been submerged but looked in good condition (Figure 35).

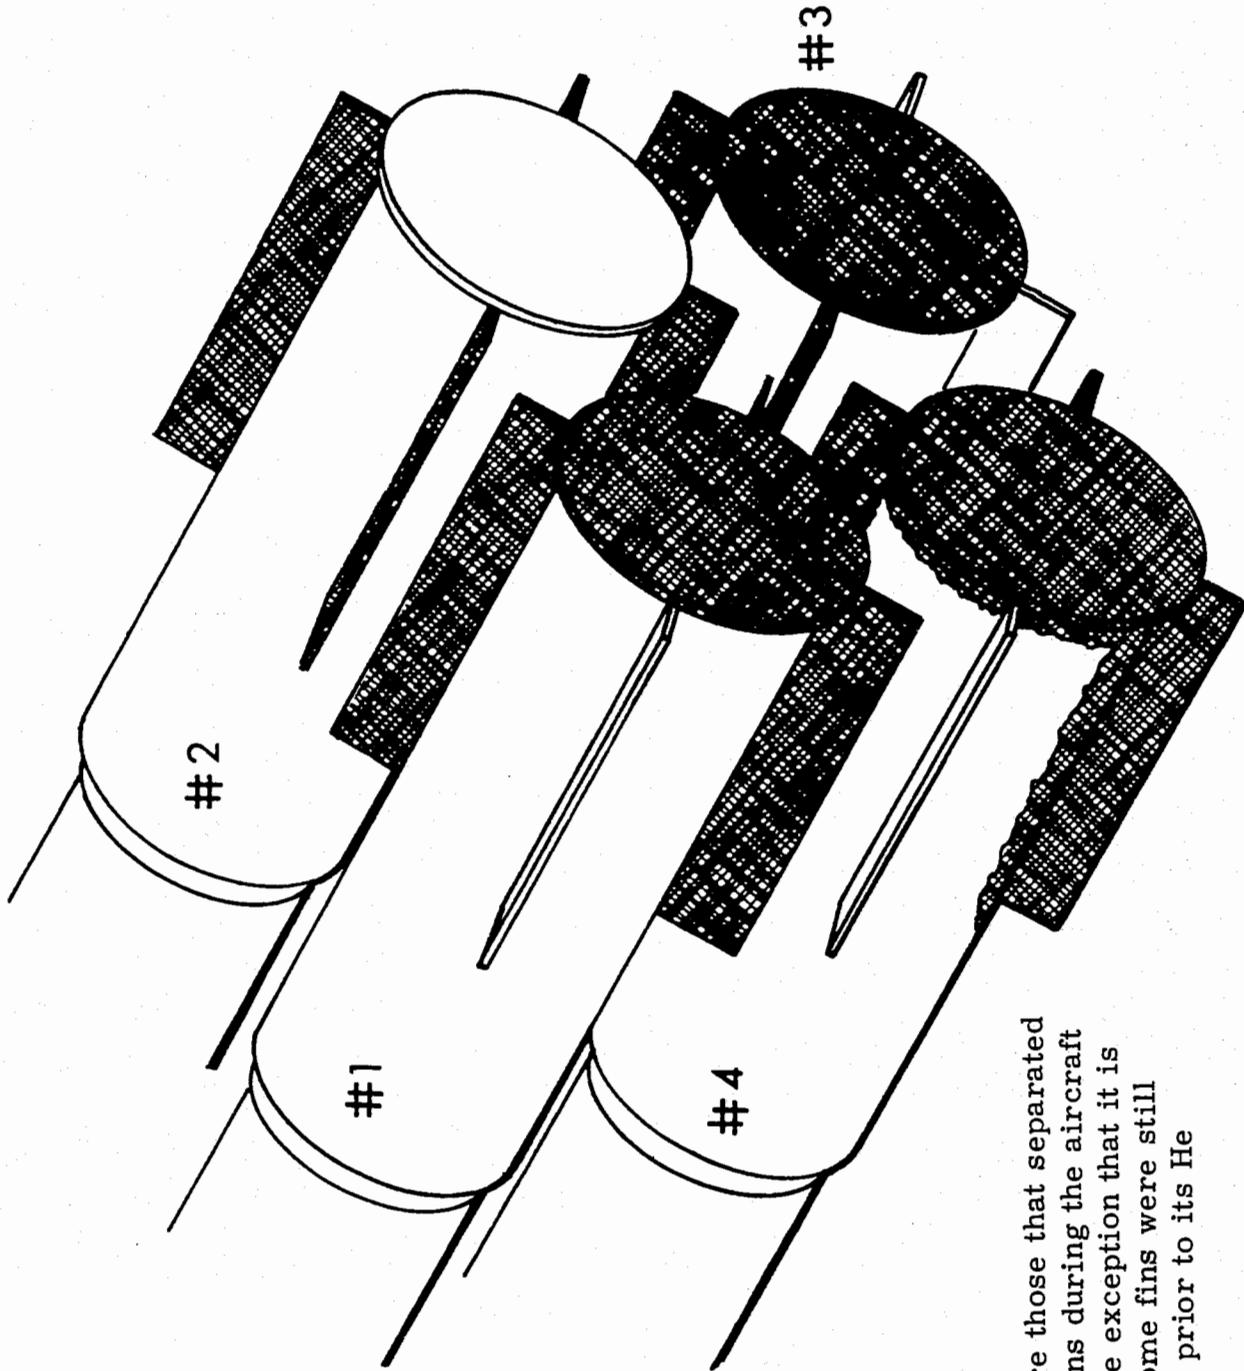
Note: Shaded parts are those that separated from the weapons during the aircraft breakup with the exception that it is possible that some fins were still with Weapon #2 prior to its He detonation.

Note: Three fins were found between the aircraft - not afterburner debris (was close to the debris) by Capt Goodenham as disclosed 3-2-67

Figure 44. Weapon Damage at Aircraft Breakup
