Development Report

B-52/KC-135 COLLISION

NEAR PALOMARES, SPAIN (U)

S. V. Asselin, 1544
Sandia Laboratory, Albuquerque

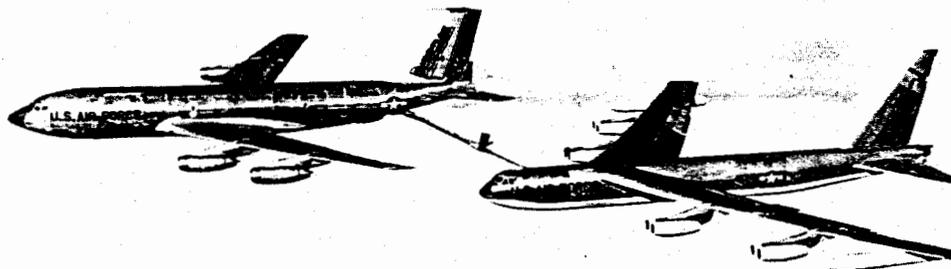
Figure 1. KC-135/B-52 Mid-Air Refueling

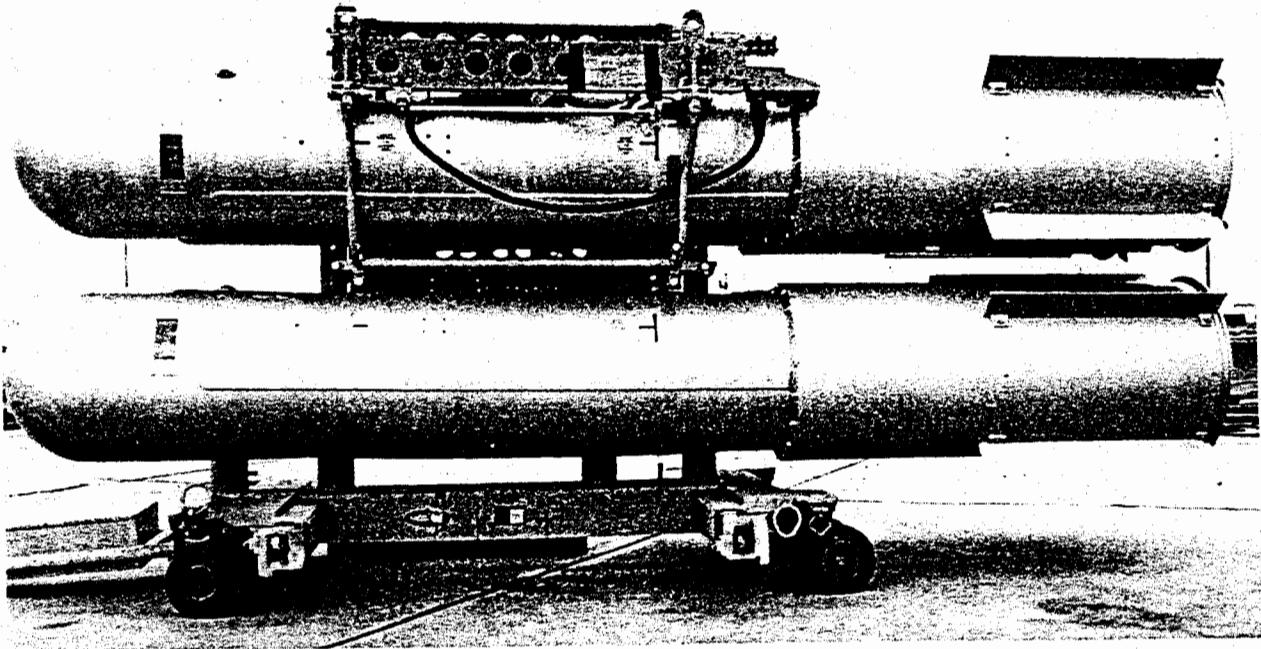
On January 17, 1966, a B-52G aircraft carrying four Mk 28F1(Y1) weapons in an MHU-20/C clip-in assembly (Figures 1 and 2) collided with a KC-135 tanker in the vicinity of the village of Palomares on the southeast coast of Spain (Figure 3). The accident occurred at 10:25 AM, local time, in good weather. The accident happened during a routine refueling of two airborne alert (Chrome Dome) B-52G aircraft from Seymour Johnson AFB, North Carolina, by two KC-135 tankers from Moron AFB, near Sevilla, Spain.

Figure 2. Mk 28FI Bombs in MHU-20/C Clip-In Assembly

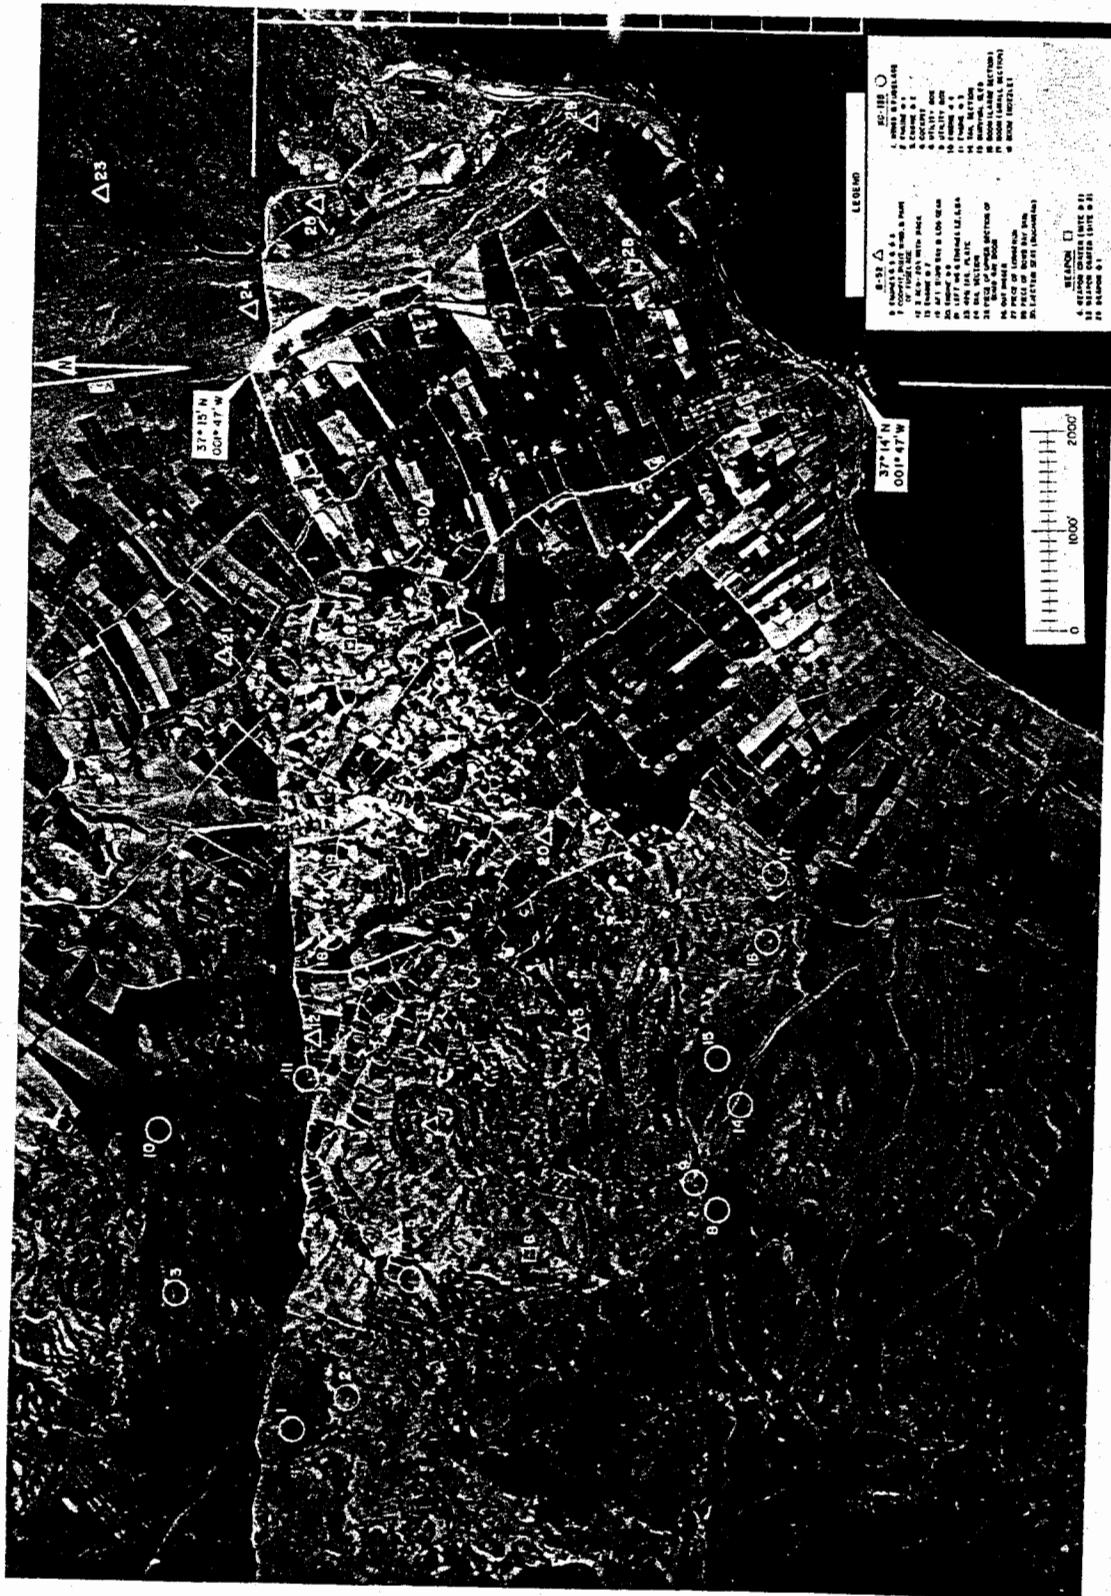
Because of late arrival on Tuesday, activities started on Wednesday morning with a briefing of recovery operations to date by Col. Rhodes. Three weapons had been located by this time. The first was being guarded by Guardia Civil (Spanish federal police) personnel when the first U. S. Air Force group arrived. The second and third weapons were found by U. S. Air Force personnel early on Tuesday, January 18. The debris pattern on land is described in Figure 4.

Figure 4. Photo Map Showing Debris Pattern on Land

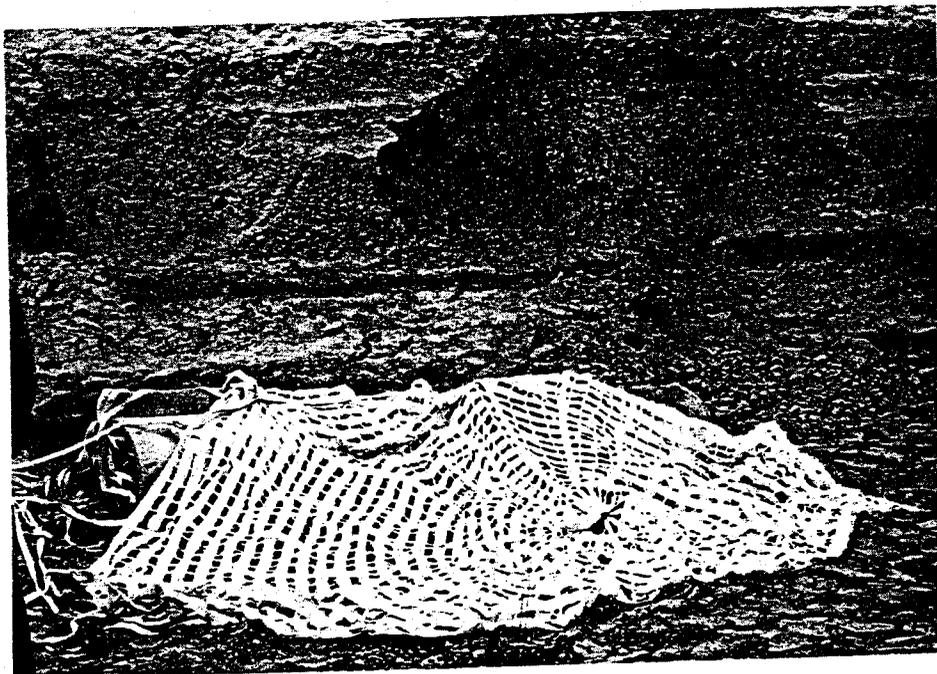
Weapon #1 (Left upper position in clip-in assembly) -- The weapon was in relatively intact condition, having been retarded by abnormal deployment of the 16-1/2 foot parachute and impacting on a steep bank of soft earth. The nose section of the fuze was crushed and dented and the afterbody (shape component) suffered a few dents. The tail plate and three fins were missing. The MB-3A

Figure 6. Weapon #1

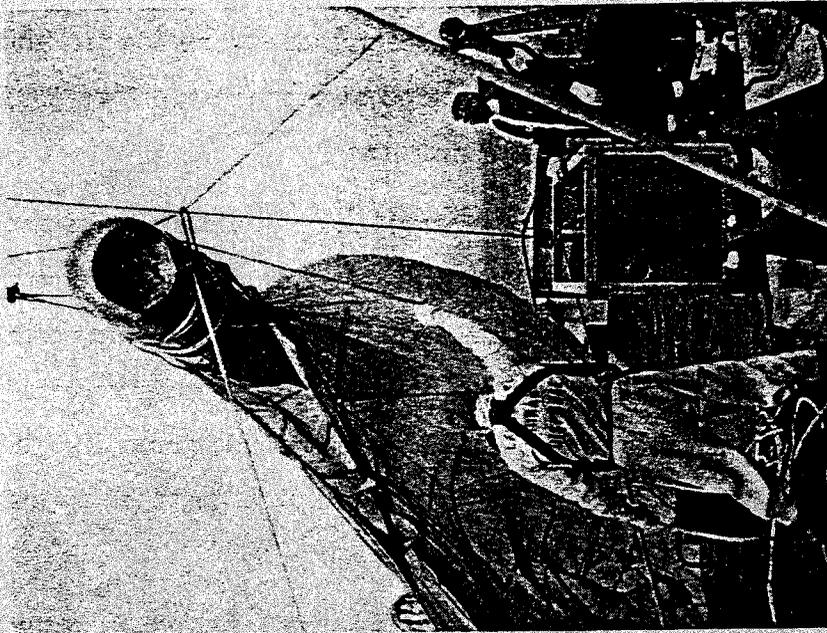
D66-12527
C66-1768

On April 7, the weapon was lifted aboard the USS Petrel, a submarine rescue vessel (Figures 22, 23, and 24). As previously arranged, General Wilson, Lt. Col. M. Neal, DNS, and S. V. Asselin were brought aboard for this operation. The weapon was lifted most of the distance by two lines attached to the parachute. The lift was complicated in that the CURV (Cable-Controlled Underwater Research Vehicle) was tangled with the parachute during an attempt to attach a third line and was lifted at the same time as the weapon. When the weapon was within 100 feet of the surface, EOD divers attached an additional line around its casing and the CURV was freed from the parachute.

Figure 23. Weapon #4

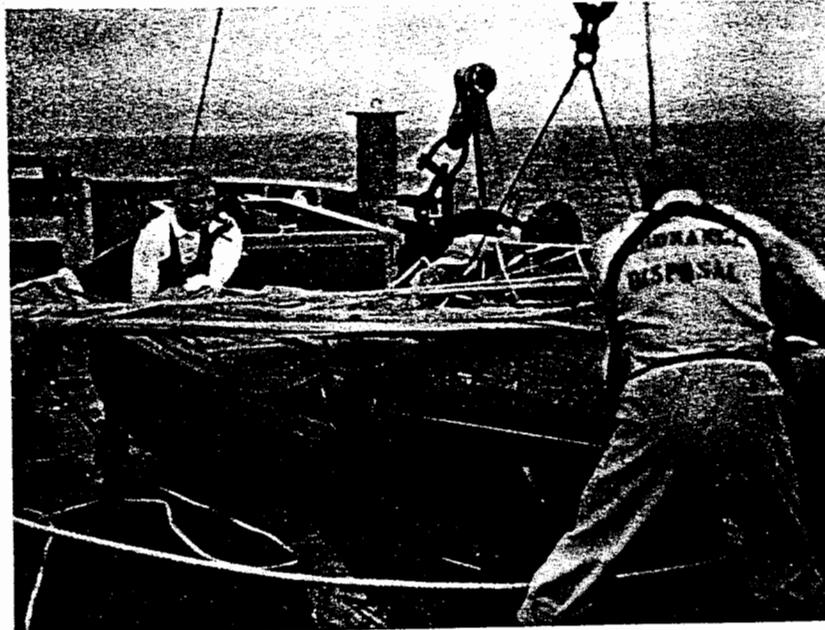
D66-12518

Figure 24. Weapon #4

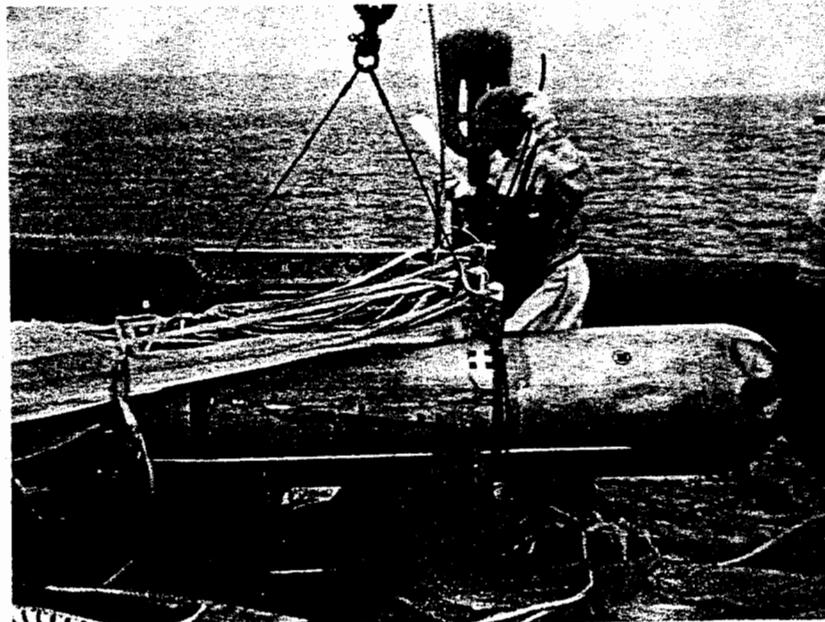
D66-12579

The weapon was placed on a wooden stand (Figure 25) for the render safe and disassembly procedures.

Figure 25. Weapon #4

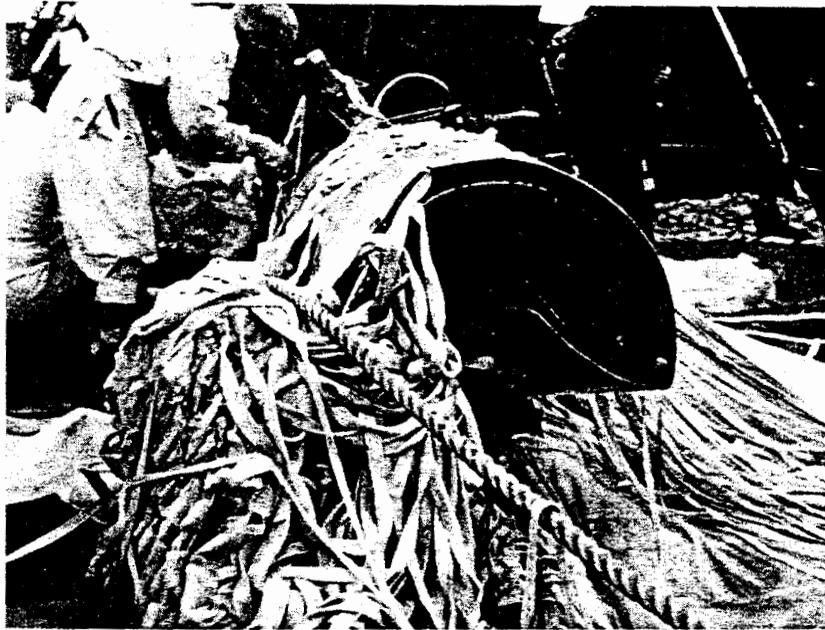
D66-12522

recovered), and deployment of both 16-1/2 and 64-foot parachutes (Figure 28). In addition, separation from the aircraft resulted in the extraction of both pullout rods (Figure 29) and the retention of the MB-3A rack and a beam from the MHU-20/C clip-in assembly (Figure 30).

Figure 28. Weapon #4, 16.5-Foot Chute on Left, 64-Foot Chute on Right

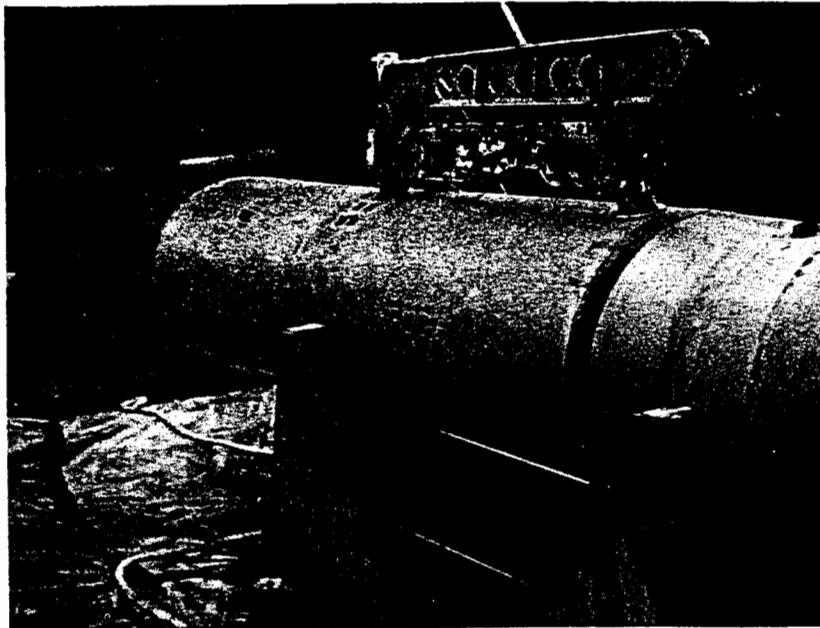
D66 - 12520

Figure 30. Weapon #4, MB-3A Rack and Portion of MHU-20/C Clip-In Assembly

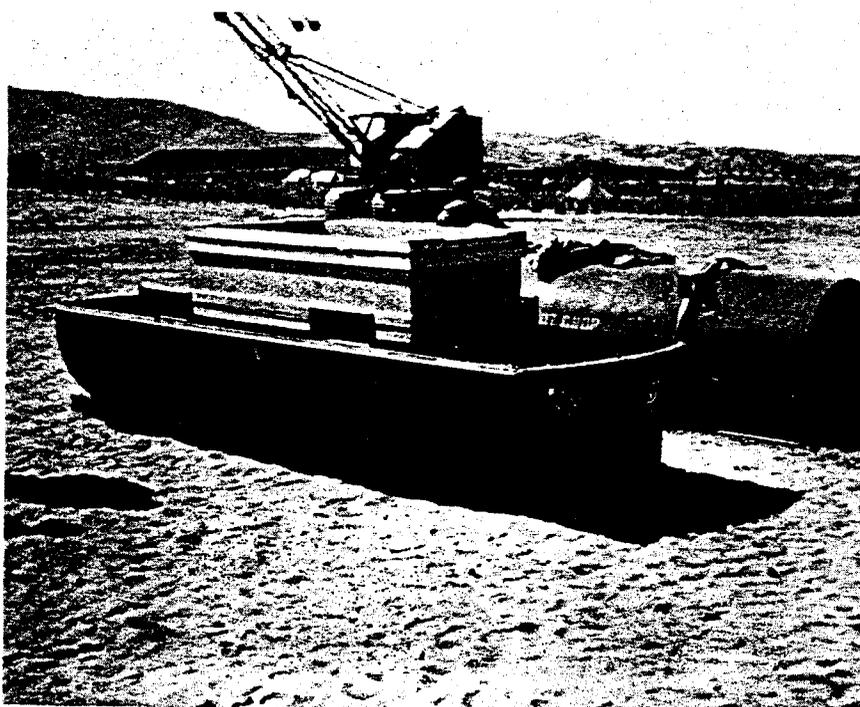
D66 - 12576

All bomb components except the parachute were placed on a bed of sand in the container bottom, with the warhead portion contained in the center wood box. The warhead was then covered with sand, the other components shored in place, and the cover put in place (Figures 41, 42, and 43). The two parachutes were packed together in a 55 gallon drum for shipment.

Figure 41. Modified J79 Engine Container

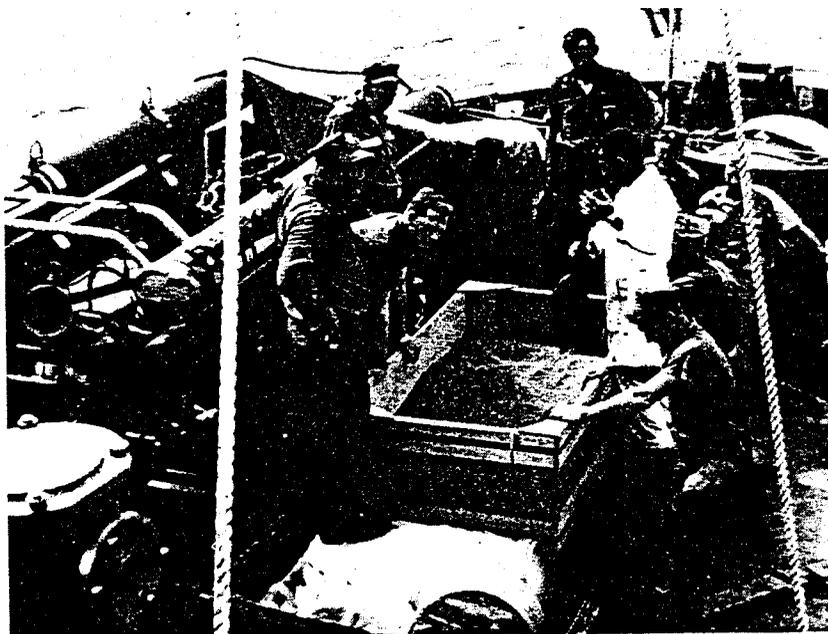
D66 -12570

Figure 42. Weapon #4 Warhead Being Covered with Sand

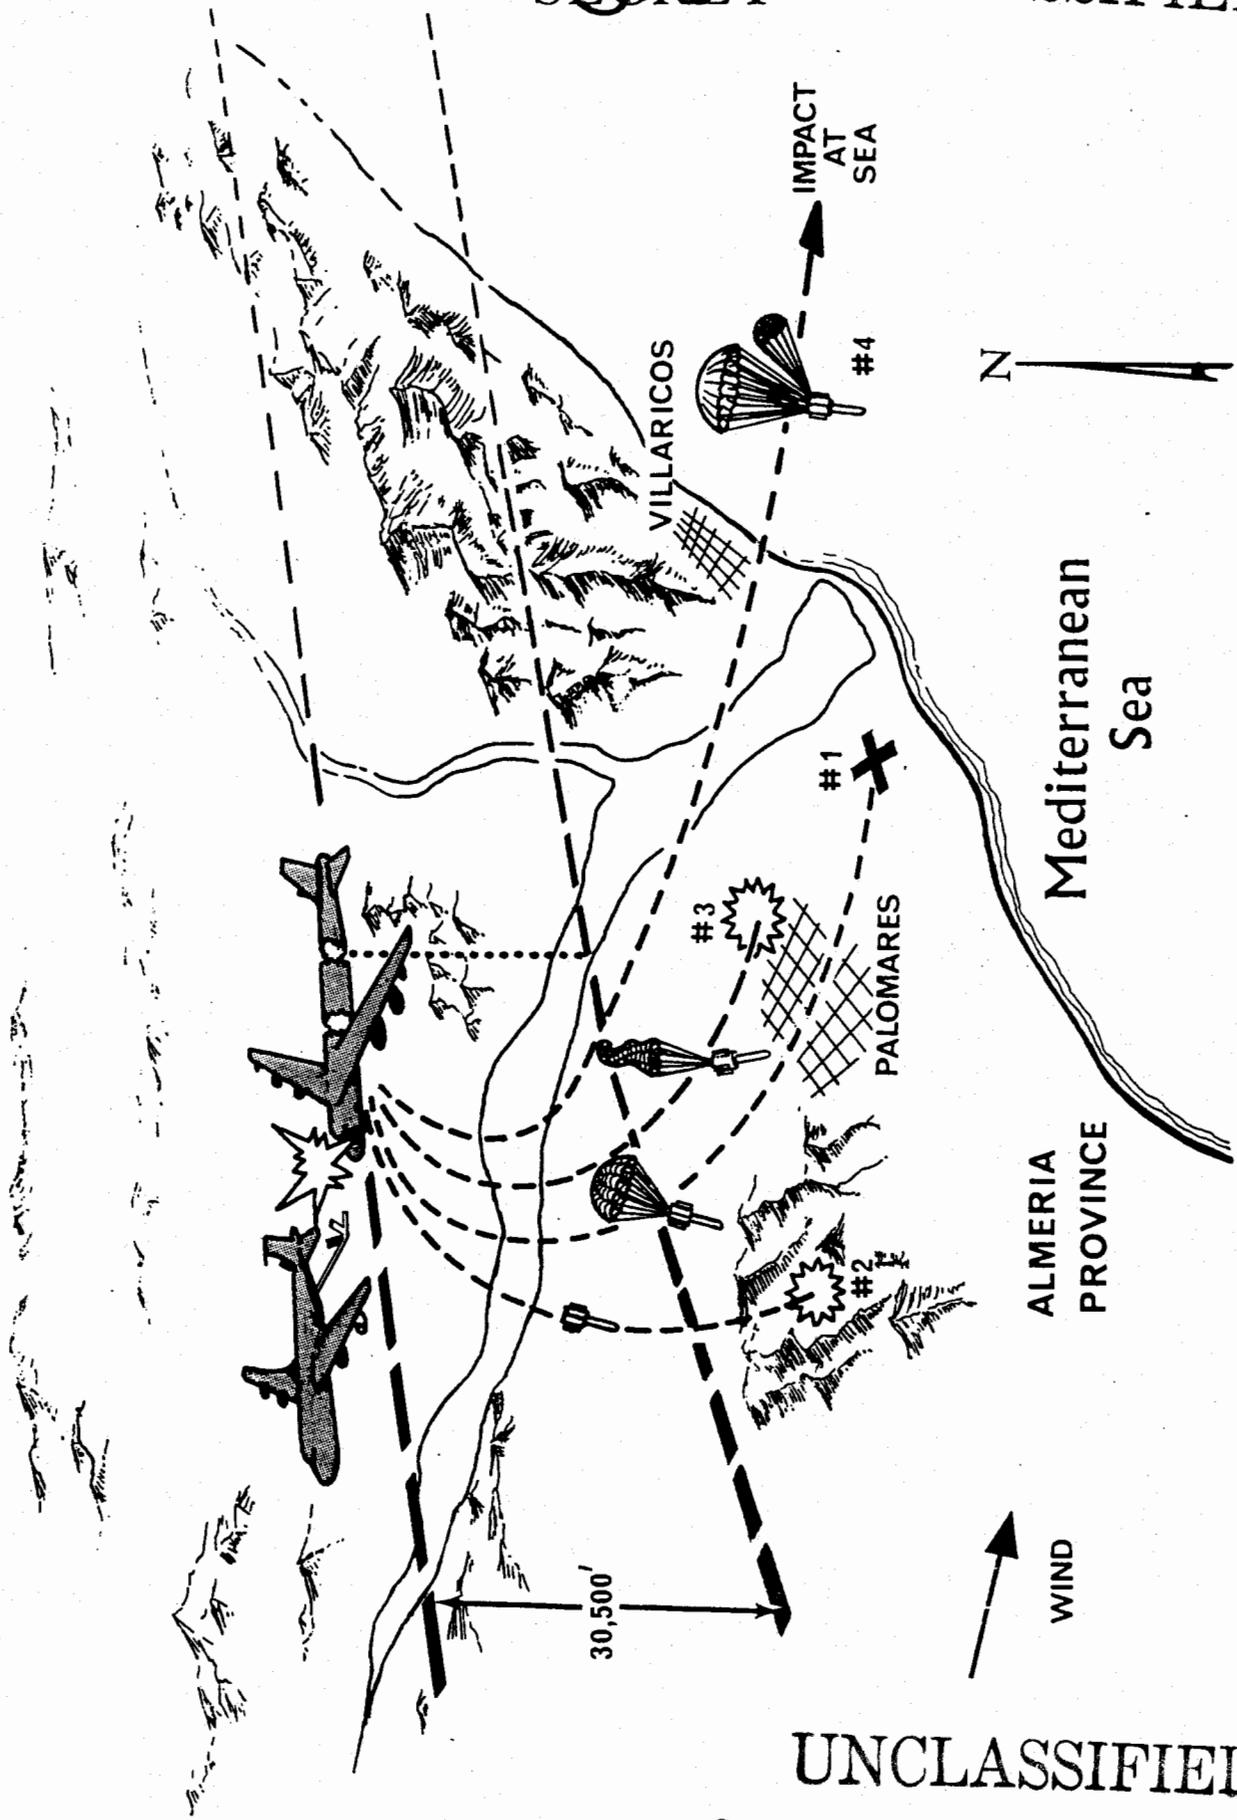
Figure 45. Dispersal of Weapons After Collision
